Inspection report for the property at
123 Main St., Anytown, MA 00000

JBS Home Inspections, Inc
Office - 617-924-1028 Cell - 617-480-1163
alex@jbsinspections.com
<http://www.jbsinspections.com>

Inspected by: Alex Steinberg

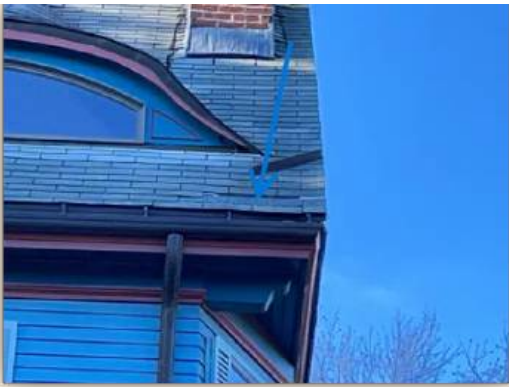
**(R-1) Major Deficiency:** The roof covering on this house was asphalt shingles, which typically last between 20 and 30 years. Portions of the roof appeared to be 30 plus years old. The shingles were dried out and the protective granules were wearing off. There were missing and cracked shingles. This roof is fully depreciated. I recommend that a licensed roofer replace this roof.

Missing shingle

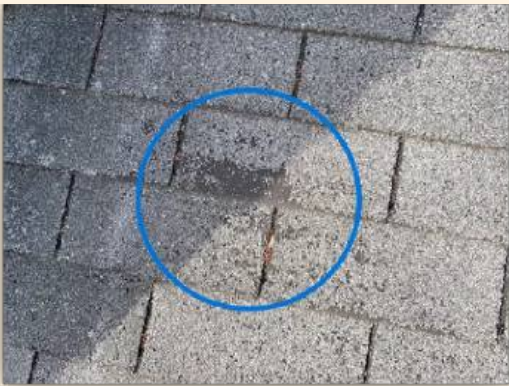
Protective granules worn off shingles

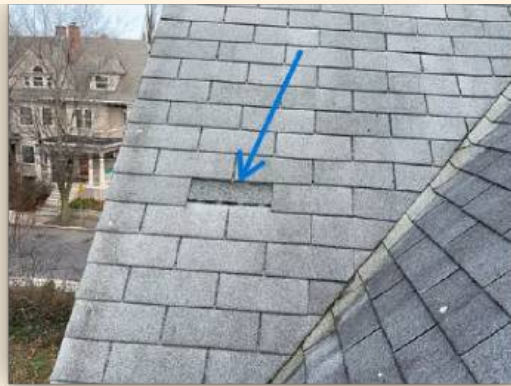
Protective granules worn off roof

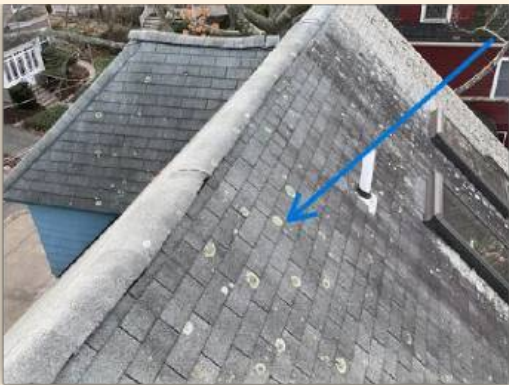
Missing/broken shingle

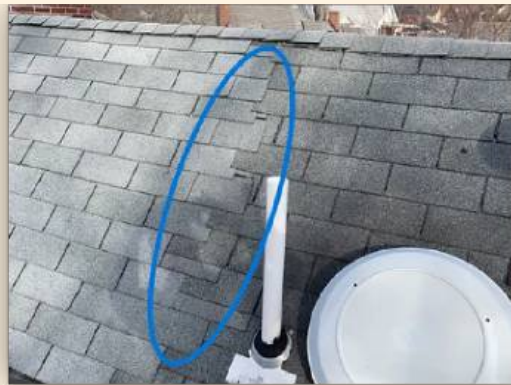
Old roof

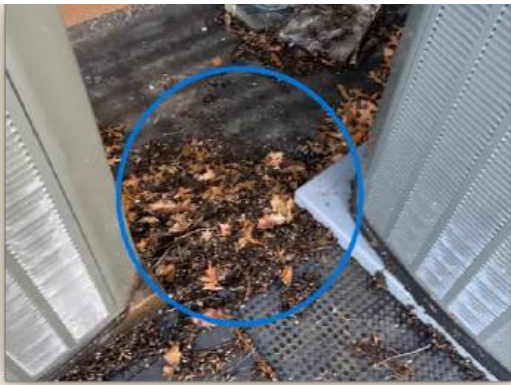
⚠ (R-2) Major Deficiency: The flat roof was covered with a rubber membrane at the right rear of the house, under the 3rd floor deck. Rubber membrane is a quality roof covering that usually lasts 25-35 years. It is important that the seams between the sections of rubber stay sealed. This roof was at least 30 years old. The material was dry and the underlayment was soft in areas suggesting leaks. There were open seams at the connections to the wood deck posts. There was new wood and new siding at the house suggesting issues with the roof connection to the wall of the house. Under the new wood and new siding the rubber membrane was presumably run up the house higher. I recommend that this roof be removed and replaced soon to avoid leaks and damage to the building.

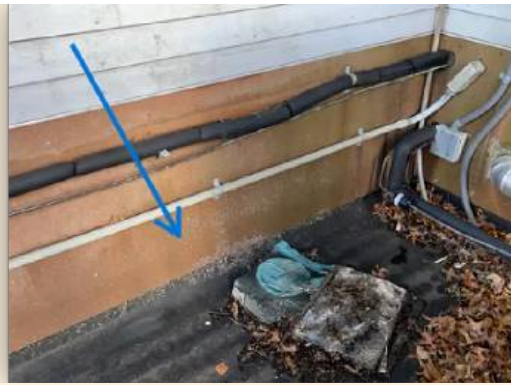
Roof soft

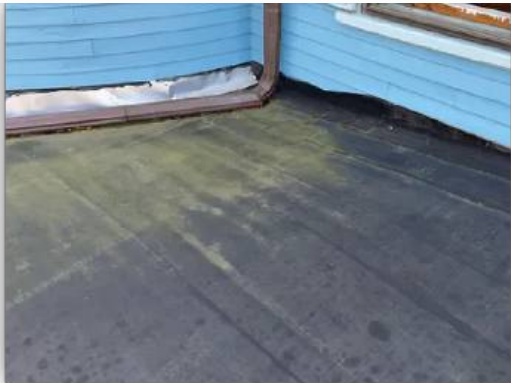
Front porch

(R-3) Description: The flat roofs at the front porch and left rear of the 2nd floor were covered with a rubber membrane. Rubber membrane is a quality roof covering that usually lasts 25-30 years. This roof appeared to be approximately 20 years old. It is important that the seams between the sections of rubber stay sealed. I recommend that every couple of years the roof be inspected.

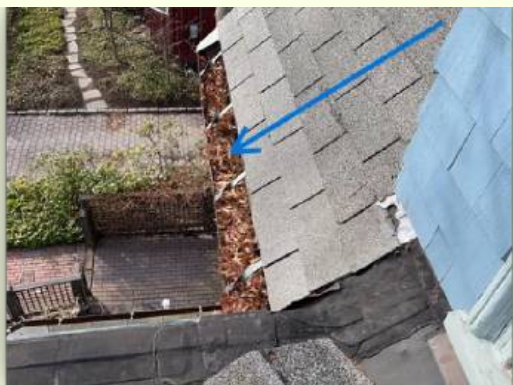
🔧 **(R-6) In Need of Repair:** The gutters on the house were filled with debris. I recommend that the gutters be cleaned out twice a year. One cleaning should occur late in the spring and the other late in the fall.

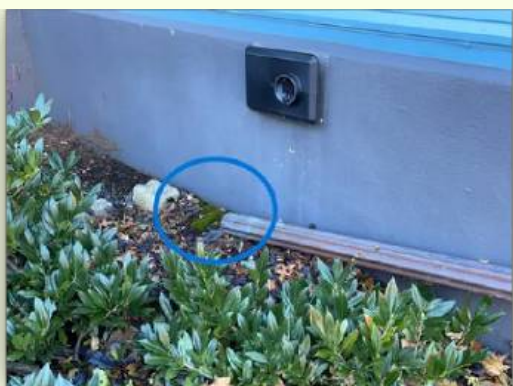
🔧 **(R-7) In Need of Repair:** There were missing downspout extensions. Downspouts carry roof water to the ground and should have extensions that direct the water to an appropriate distance, 5 or 6 feet, from the foundation. If there are no downspout extensions, or if the extensions are too short, the roof water may eventually end up in the basement. I recommend that downspout extensions be installed to carry the water to an appropriate distance from the house.

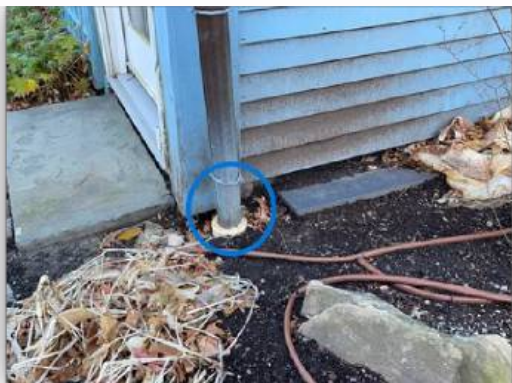
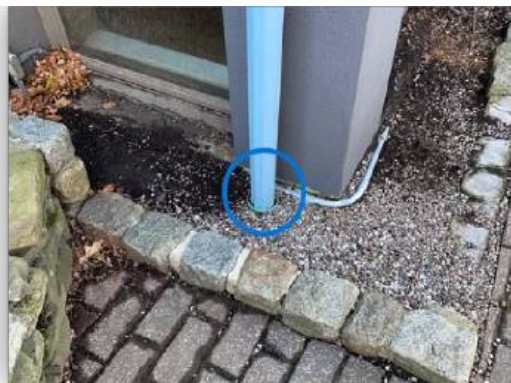
(R-8) Description: The gutter downspouts at the rear of the house discharged into underground drains. I recommend obtaining information from the seller as to where the drains terminate, in case the drains become

blocked and need to be unclogged. I recommend testing operation of the drains to ensure that they are not clogged (by checking the drains during heavy rain or with a garden hose).

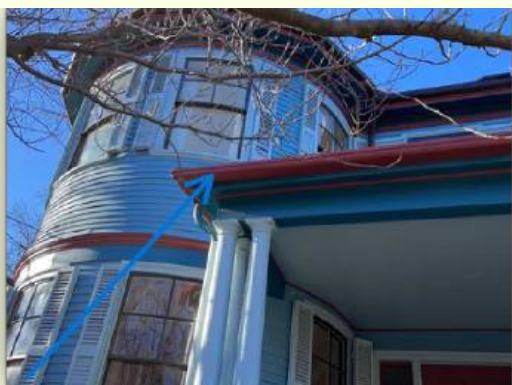
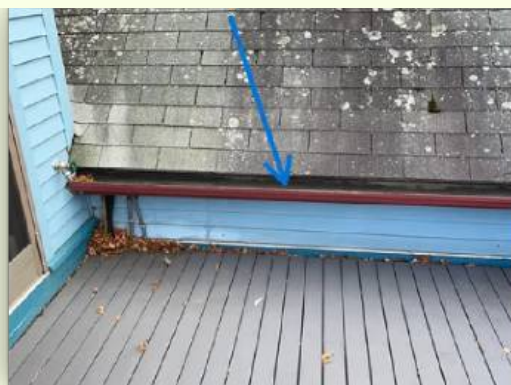
🔧 **(R-9) In Need of Repair:** There were wood gutters on this house. As well as cleaning the gutters out at least twice a year, wood gutters require regular oiling. Every couple of years the gutters should be cleaned, dried, and oiled. Wood gutters are notorious for leaking. I recommend that the gutters be monitored for leaks. If found to leak, installing aluminum gutters may be the most prudent action.

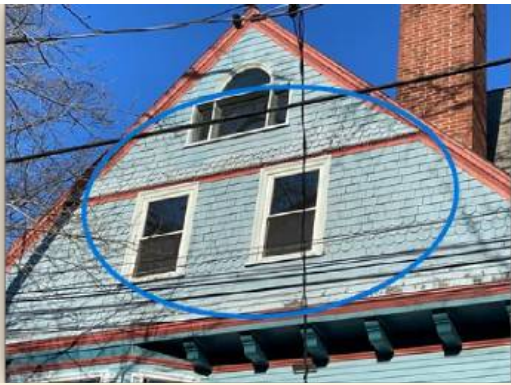
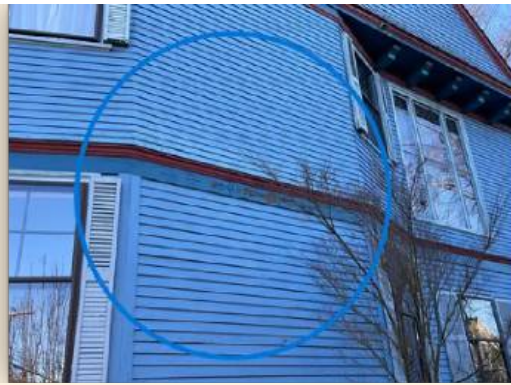
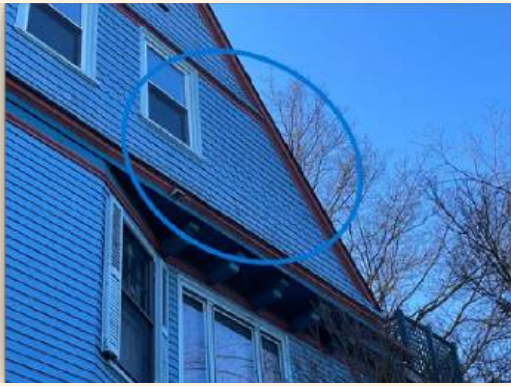
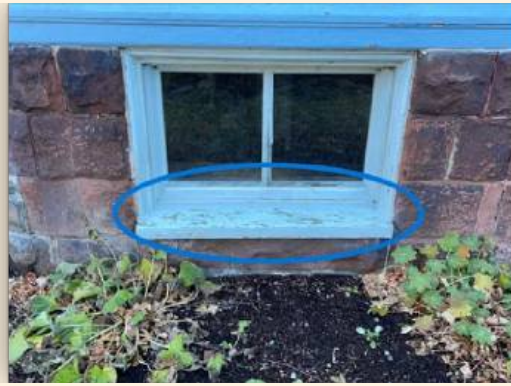
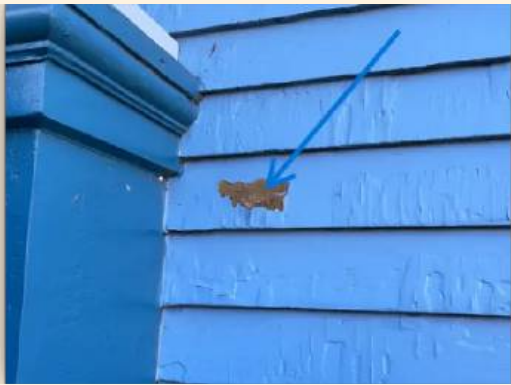
⚠️ **(E1-1) Major Deficiency:** The paint was chipping and peeling in many places on the siding and trim. The longevity of a paint job depends primarily on the prep-work. The house should be scraped, caulked and a full coat of primer applied before the finish coat. I recommend that the house be properly prepped and re-painted.

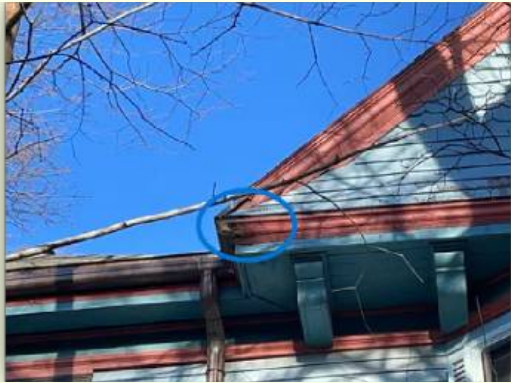
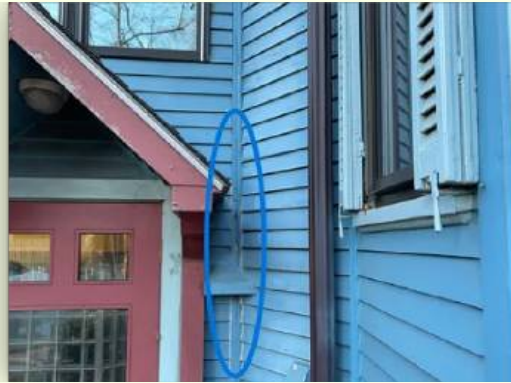
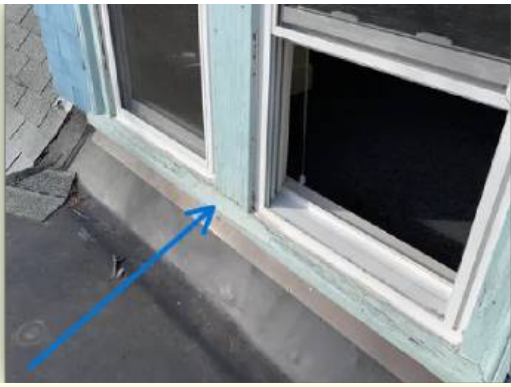
🔧 **(E1-2) In Need of Repair:** There was decayed trim at the exterior of the building. There is a potential for concealed damage behind the decayed areas. I recommend that a qualified contractor remove and replace all decayed wood prior to painting the building.

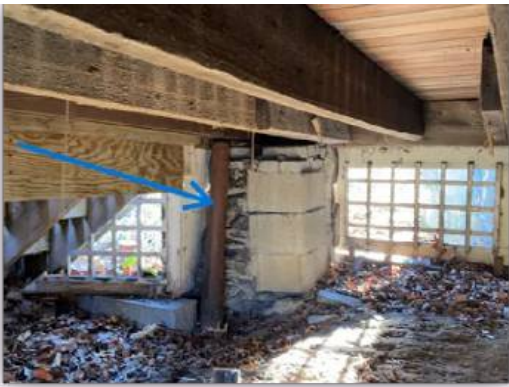
**(E1-6) Future Repair:** The structure under the front porch was older. There were new supports added that have failed. The concrete filled steel columns were rusted and have fallen over, the block columns were also loose and have fallen over. The joists were also far apart by today's standards. There was decay at the railings I recommend that the structure of the front porch be replaced by a licensed and qualified contractor.

Post no longer upright

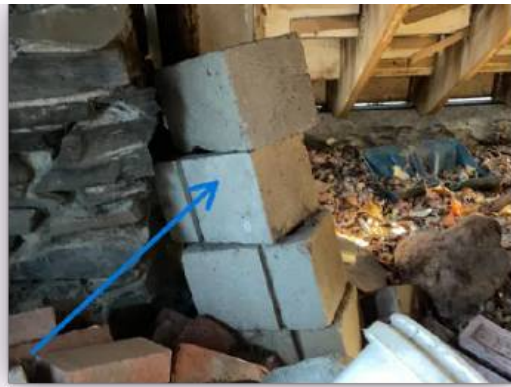
Loose blocks

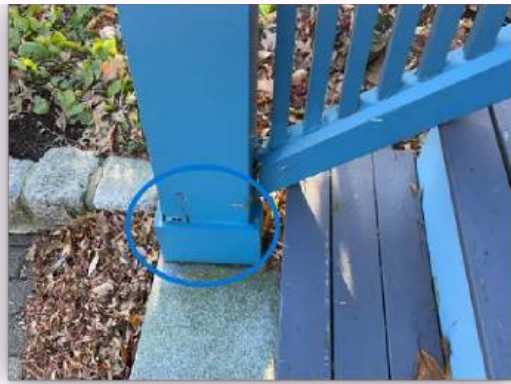
Decayed railing

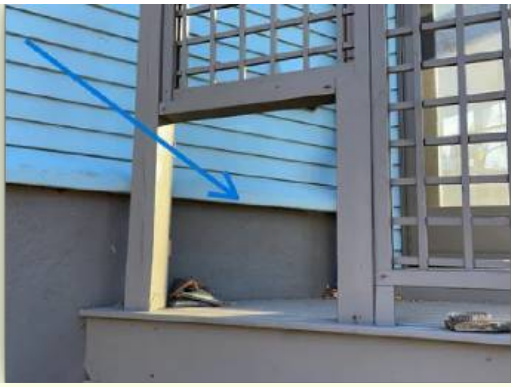
🔧 (E1-10) In Need of Repair: There was a missing section of railing at the rear deck. There is a potential for someone, a small child, to fall from this deck. I recommend that the railing be repaired or replaced.

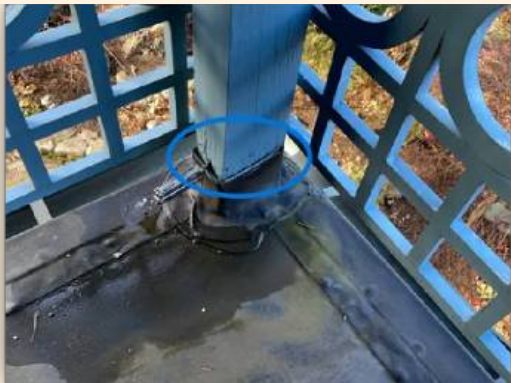
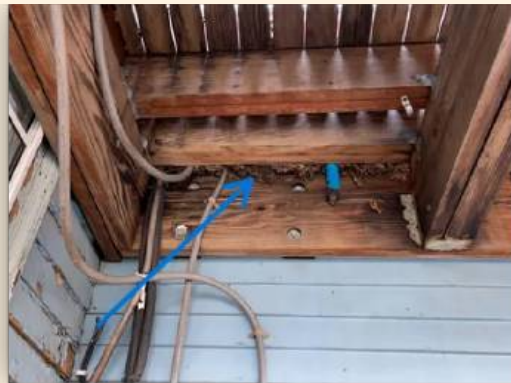
⚠️ **(E1-11) Major Deficiency:** There was rot at the 3rd floor rear deck. At the 2nd floor the rubber membrane roof was leaking around the deck support posts, this was causing rot. The outer posts was no longer structurally viable. There was a high concentration of peeling paint at the inner corner. There was a roof valley above with a small wood gutter. The gutter may become overwhelmed and water runs down the inner corner of the building. There is a potential for concealed damage in this area. When the rubber roof is replaced at the 2nd floor this deck should also be replaced.

Debris between deck and house

Signs of rot

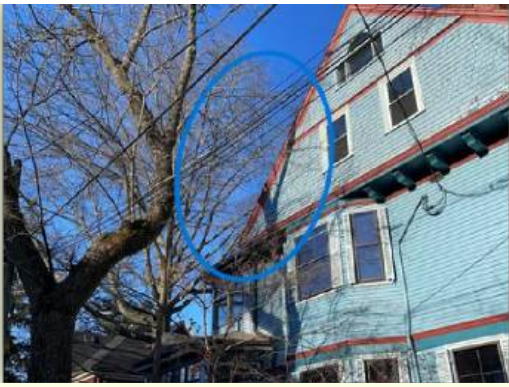
🔧 **(E1-12) In Need of Repair:** Trees and shrubs were planted too close to the building. Vegetation can damage the siding, the trim and the roof, and it can clog up the gutters. Overhanging tree limbs can invite ants, squirrels etc. on to the roof. Roots from trees planted too close to the building can cause damage to the foundation and sewer lines. Areas that are too shady do not allow the siding to dry out and mildew and moss can occur. I recommend that a landscape contractor remedy this situation.

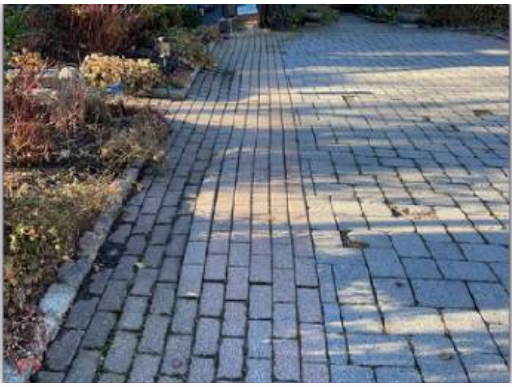
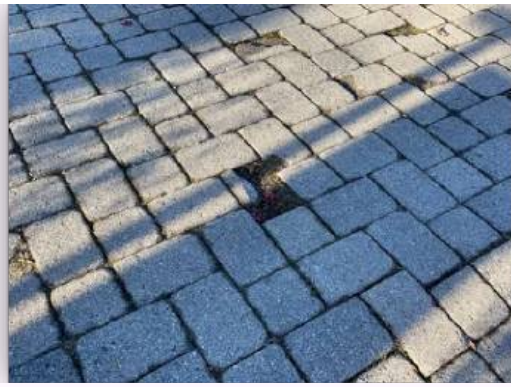
🏠 **(E1-15) Future Repair:** The right-hand parking area was uneven. It appears that the parking area was not constructed properly. Patios, walkways and driveways should be installed on underlayment to prevent movement in the structure due to the freeze thaw cycle of the ground. I recommend that the driveway be removed and installed on a proper underlayment, 8-12 inches of compacted stone dust or sand.

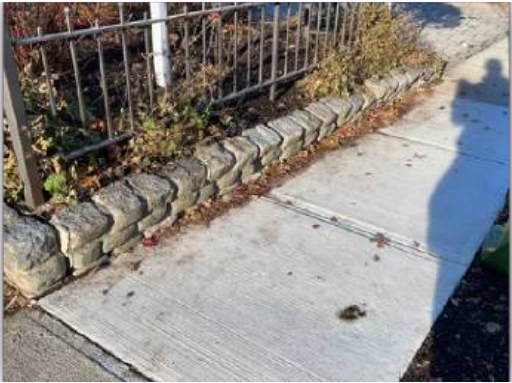
**(E1-16) Future Repair:** The retaining walls at the front of the house were too small and have shifted as a result. Retaining walls either need weep holes to allow drainage to reduce the hydrostatic pressure or they need mass to stand upright. These walls were too small and did not have weep holes and thus are leaning and cracked. I recommend that the small retaining walls be rebuilt.

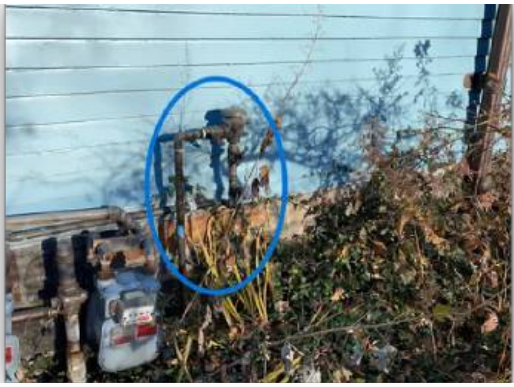
(E1-17) Description: There was irrigation system plumbing at the left side of the building. It is important that a irrigation system company blow water out of the lines before the ground freezes. This irrigation system was out of scope for this home inspection and was not inspected.

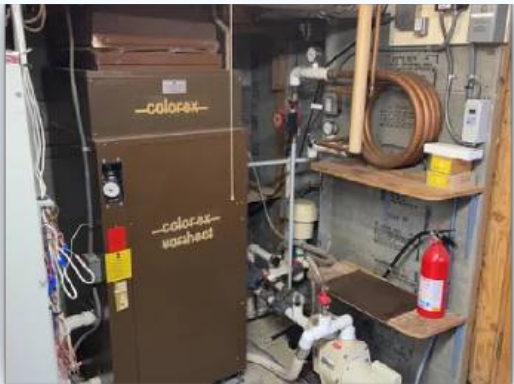
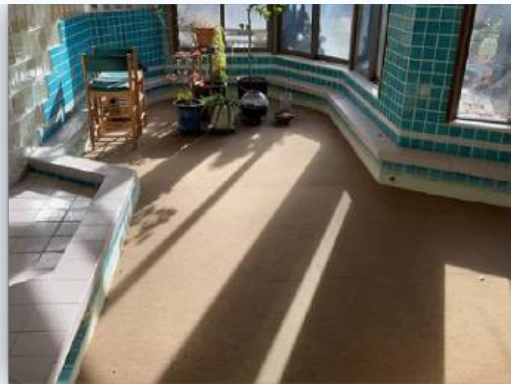
🔍 **(E1-18) Due Diligence:** The pool and its equipment were beyond the scope of this inspection. The pool was indoors and if started back up may cause moisture issues in the house. I recommend that the pool be inspected by a qualified pool inspection company to ascertain what it would take to get it going again and what it would take to install an air system to keep the house dry.

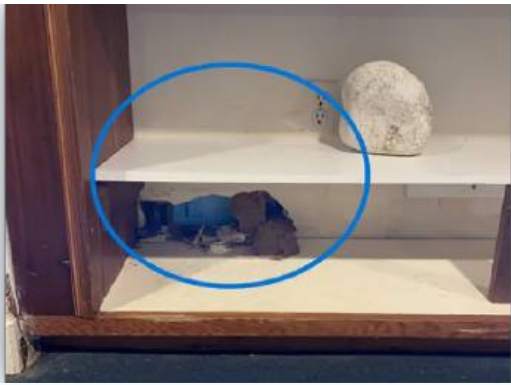
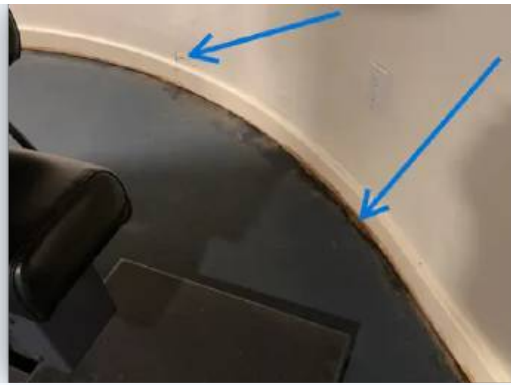
🔍 **(SC-1) Due Diligence:** At the time of inspection the basement was damp and water stained in locations around the perimeter. It is very difficult to locate the water table from a visual inspection. Furthermore it is very difficult to determine whether the basement will get wet under certain weather conditions. I recommend that the seller be asked to disclose any information of the history of water in the basement. Care should be taken to divert ground water and roof water away from the house.

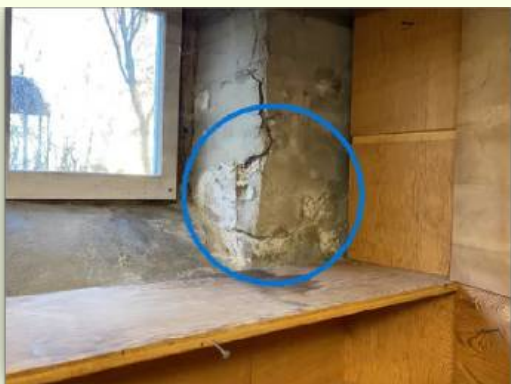
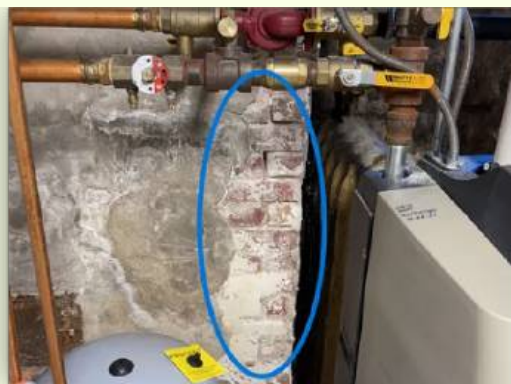
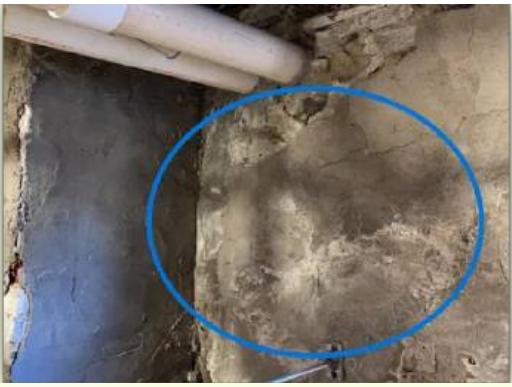
🔧 (SC-3) In Need of Repair: At the inside the foundation walls there were signs of efflorescence. These salt deposits are caused by moisture seeping through the concrete and leaving salts from the concrete on the surface. I recommend that this area be monitored for further water penetration.

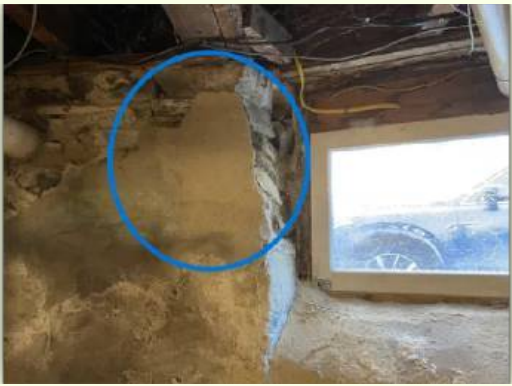
🔧 **(SC-4) In Need of Repair:** The foundation in the basement had some loose mortar and the parge coat of concrete applied to the inside of the foundation walls was decayed. Because mortar secures the stones in the foundation, too much loose mortar can cause serious structural problems. I recommend that the foundation in the basement be prepped and re-pointed and/or re-parged.

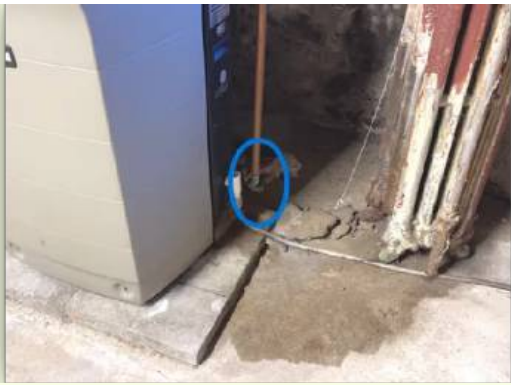
🔧 **(HCAC-4) In Need of Repair:** There was corrosion at the bottom of the pressure relief valve extension at the floor boiler. There was also water on the floor around the extension. Corrosion indicates that there has been water leaking out of the pipe. If a boiler is working properly, no water should flow out of the pressure relief valve extension pipe. I recommend further investigation and repair by a heating system company.

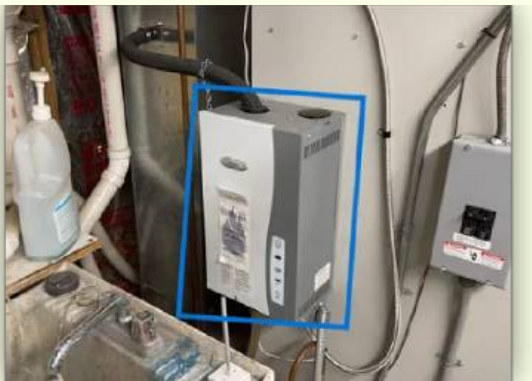
⚠️ (HCAC-9) In Need of Repair: There was a steam humidifier on the basement air handler. These require yearly cleaning and servicing for proper function and a full lifespan.

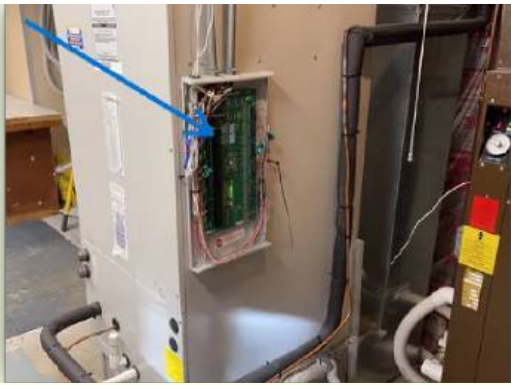
⚠️ (HCAC-10) In Need of Repair: There was a missing cover at the basement air handler computer. I recommend that this cover be installed.

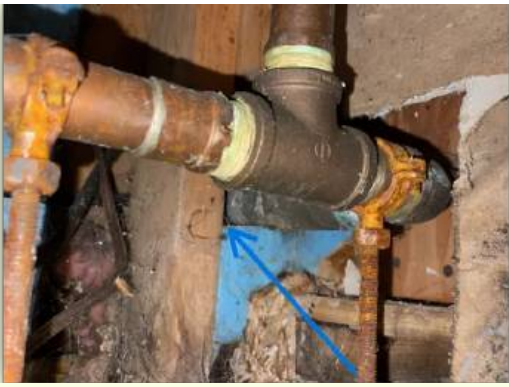
🔧 **(P-2) In Need of Repair:** The water main entered the building at the left side of the basement. It was not possible to inspect the water main pipe material as the concrete floor was poured around the pipe. I recommend obtaining information from the water department in the City of Cambridge as to the age and type of material of the water main.

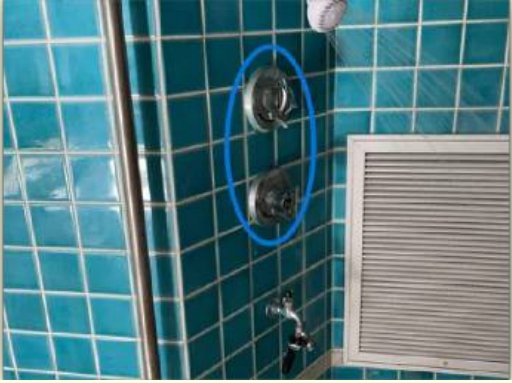
🔧 **(P-6) In Need of Repair:** The shower faucets leak in the basement shower area. I recommend that the fixtures be repaired or replaced by a licensed and qualified plumber.

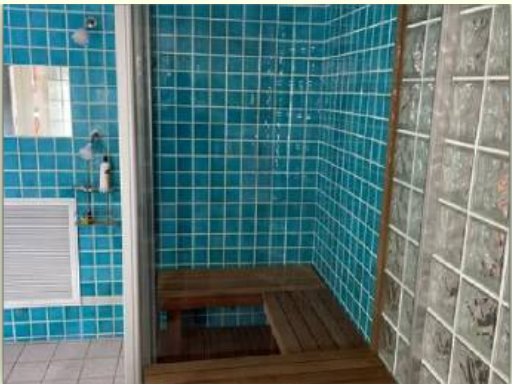
🔧 **(P-7) In Need of Repair:** The steam room was not operated at the time of inspection. The controls are not visible or readily accessible. Information should be obtained from the seller as to whether this steam room is operable.

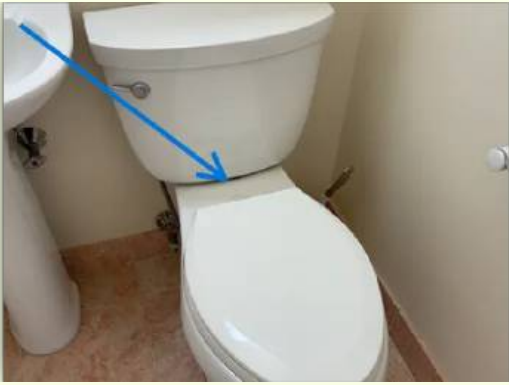
🔧 (P-12) In Need of Repair: The third floor toilet leak between the tank and the bowl. I recommend that the toilet be repaired or replaced.

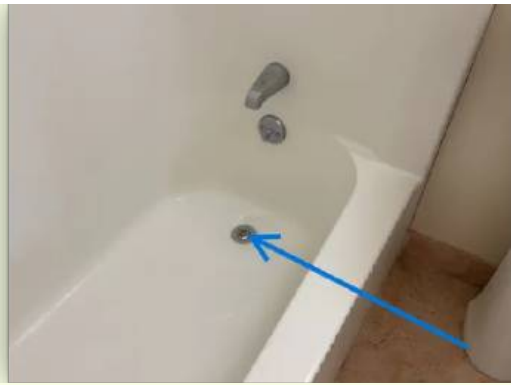
🔧 (P-17) **In Need of Repair:** Many sink/tub pop-ups did not operate in the house. There is no way to hold water in the fixtures with these pop-ups. I recommend that a licensed plumber repair or replace the pop-ups.

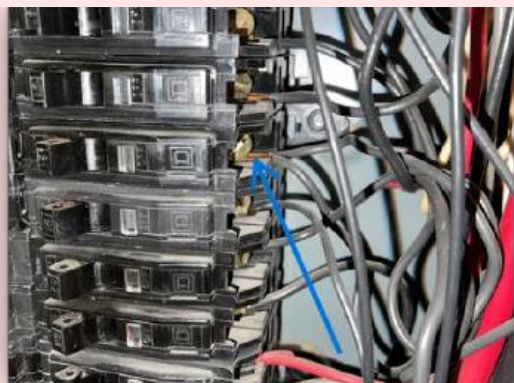
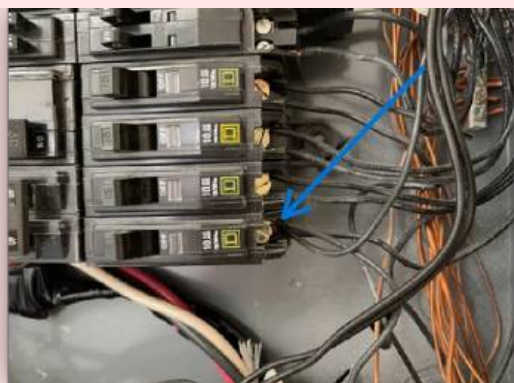
⚡ (E-3) Safety Issue: There were double taps in the electric panels. Double taps in the electrical system are a safety hazard; one wire, not two, should connect the circuit to the breaker or fuse lug. People double tap to add more circuits to an electrical system without installing a new breaker. This can be dangerous because two wires cannot be properly tightened and may cause arcing and a fire. I recommend that a licensed electrician correct this problem.

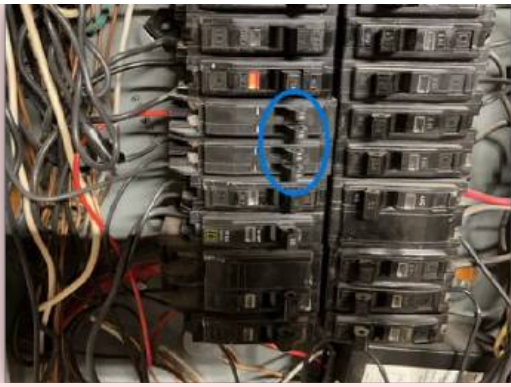
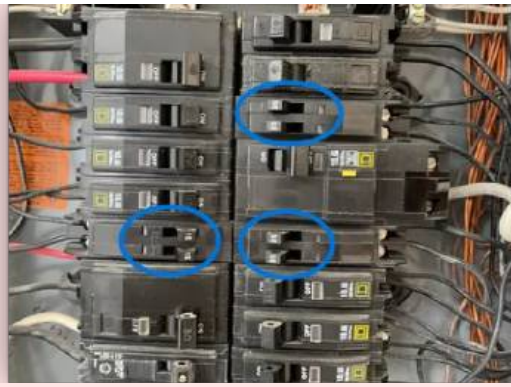
⚡ (E-4) Safety Issue: The basement main panel and the 3rd floor main panel were not rated for the mini breakers that were installed in it. I recommend that a licensed electrician remove these mini breakers and install a larger panel or a sub panel, as needed.

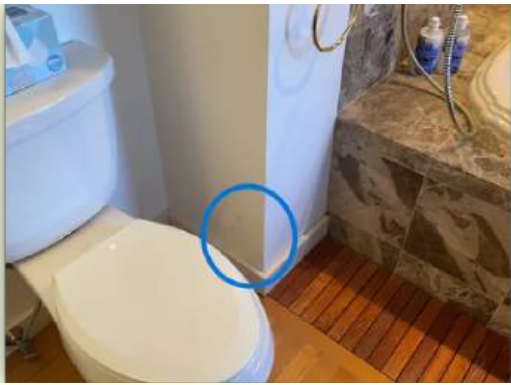
⚠ (I-2) In Need of Repair: There were stains on the wall in the 2nd floor right rear bathroom. The area was dry at the time of inspection when tested with a Protimeter non invasive moisture meter. I recommend that the area be prepped and painted and then monitored for further decay.

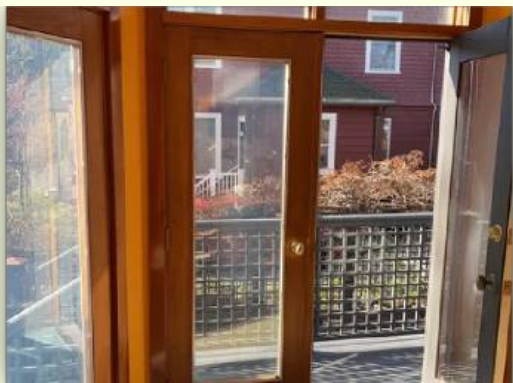
The left-hand door at the rear of the kitchen sitting area did not open. I recommend that the door be repaired or replaced so that it opens properly.

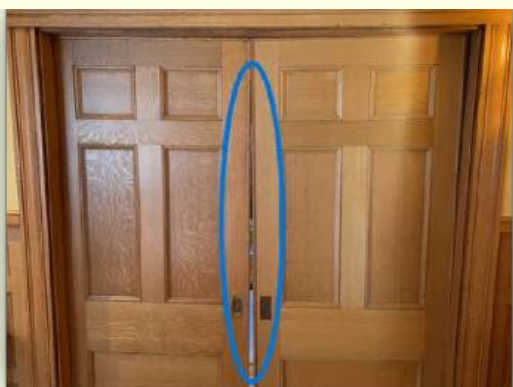
🔧 **(I-5) In Need of Repair:** The pocket doors into the right front first-floor room did not close squarely. I recommend that the doors be adjusted so that they close properly.

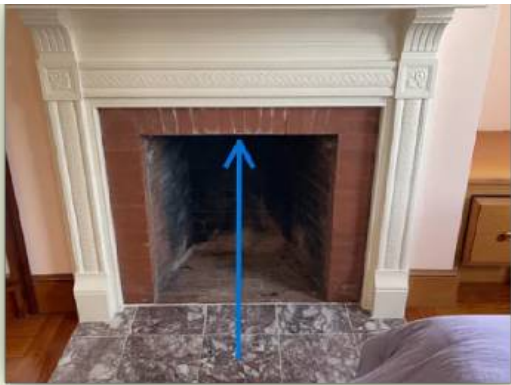
damper did not open
