Inspection report for the property at
123 Main St., Anytown, MA 00000

JBS Home Inspections, Inc
Office - 617-924-1028 Cell - 617-480-1163
alex@jbsinspections.com
<http://www.jbsinspections.com>

Inspected by: Alex Steinberg

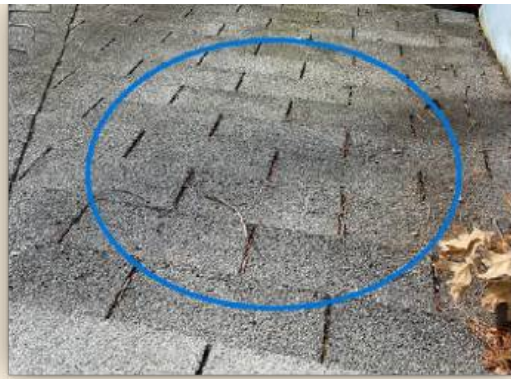
Protective granules worn off shingles

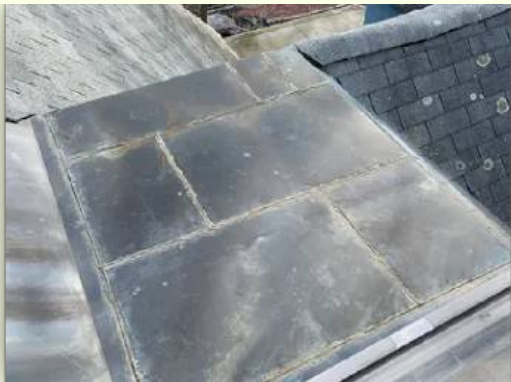
🔧 (R-4) In Need of Repair: There was a copper roof at the top of the house around the square skylight. Copper roofs are high quality and durable roofs that generally last 40 to 50 years. It is important that the seams between the sections of copper stay soldered. I recommend that this roof be monitored by a qualified roofer for wear and repaired when needed.

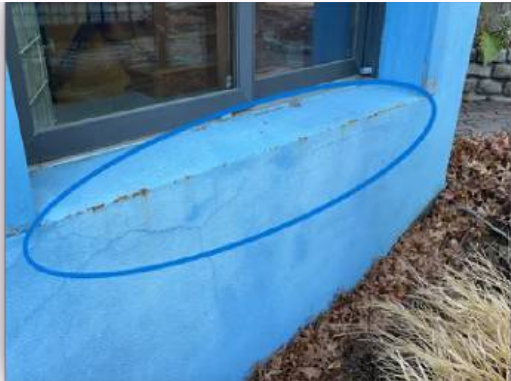
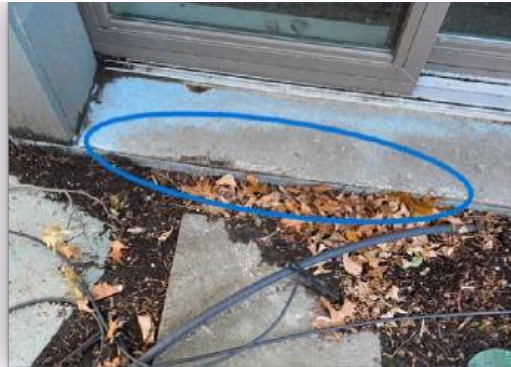
🔧 (E1-3) Future Repair: There was cracking and rust at the stucco work on the left rear of the house. There are metal corner beads that are rusting underneath the stucco. This steel will continue to rust and cause further decay. I recommend a qualified and licensed mason to repair this rear stucco area.

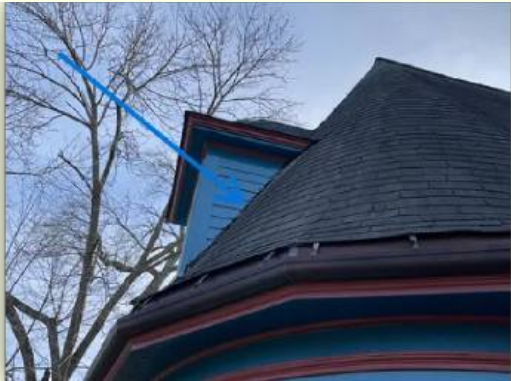
🔧 (E1-4) In Need of Repair: There was decayed siding at the front and left-hand side of the building. The older shingles were worn, cracked and curling. When the house is next painted I recommend that the decayed shingles be removed and replaced.

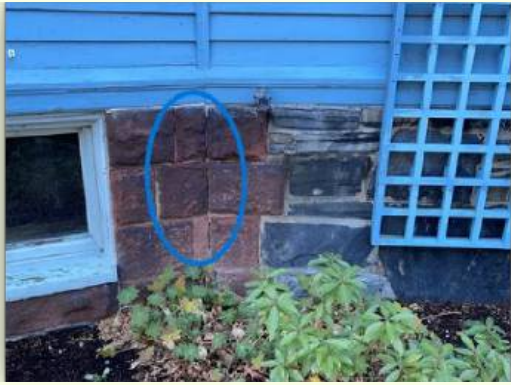
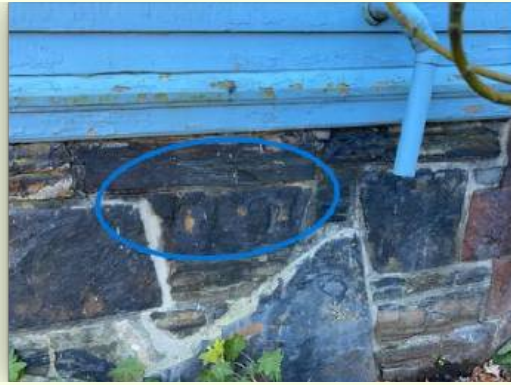
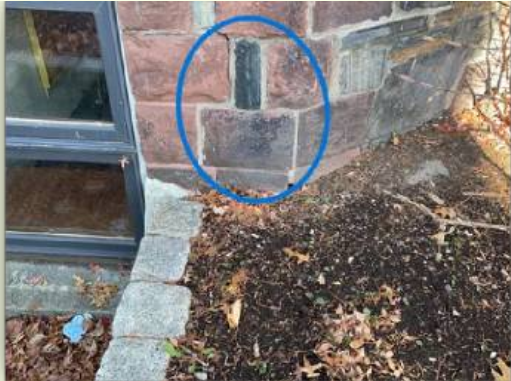
🔧 (E1-5) In Need of Repair: The masonry on the foundation needs re-pointing. Re-pointing is a process where the old grout between the brick or stone is scraped out and new mortar is applied. I recommend that a qualified

mason prep and re-point the deteriorated areas.

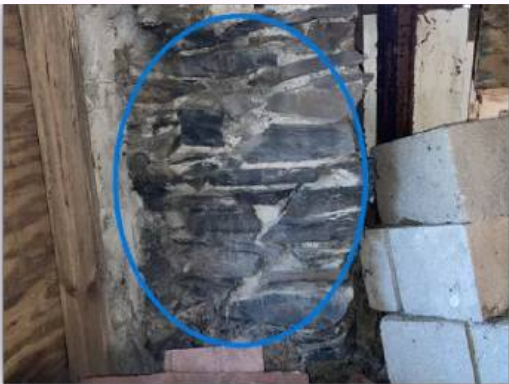
Open mortar joints at original stone columns

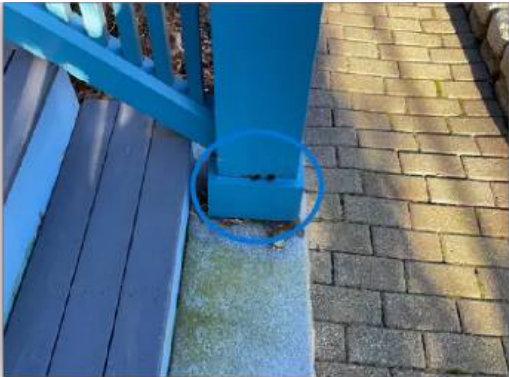
Decayed railing

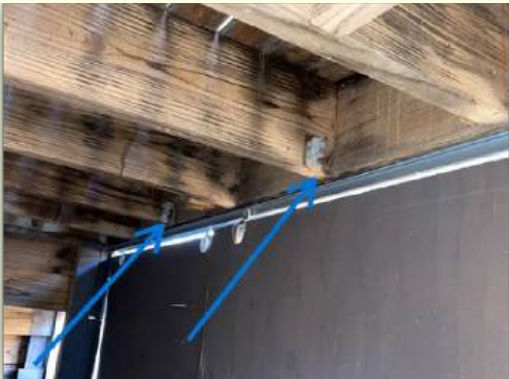
🔧 **(E1-7) In Need of Repair:** The joists were nailed into the framing at rear deck. By today's standards, this is an inadequate connection. I recommend that joist hangers be installed.

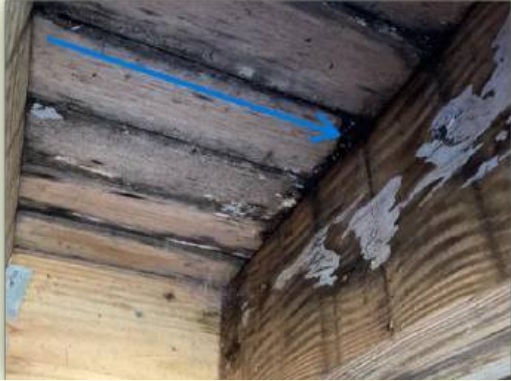
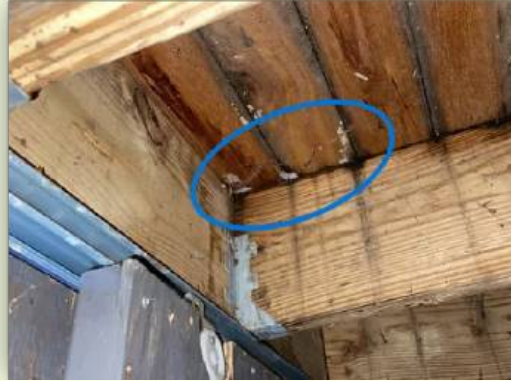
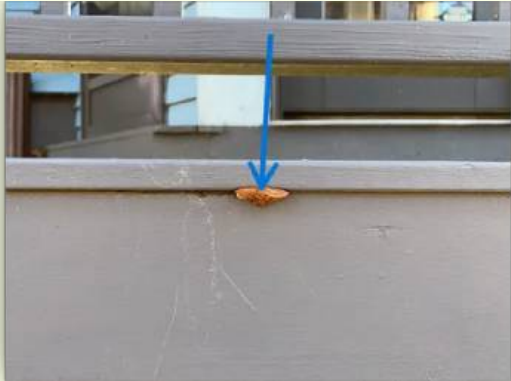
There was a rot at the rear deck. The rot was visible from underneath. The deck boards were installed without large enough gaps between the boards to allow for drainage. Leaves and other organic material will get caught in between the deck boards and create prolonged damp conditions and rot. I recommend that the deck boards be replaced

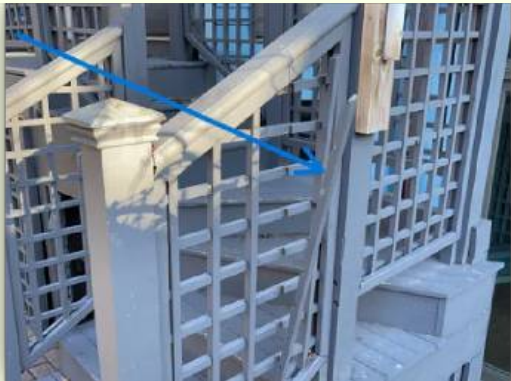
🔧 (E1-9) In Need of Repair: There was rot and broken lattice work at the rear deck railing. I recommend that the railings be repaired or replaced.

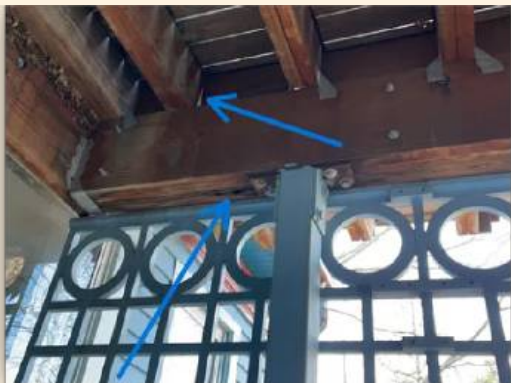
Signs of rot

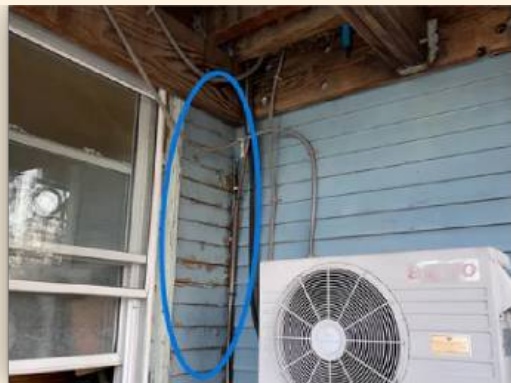
Potential for water penetration in corner

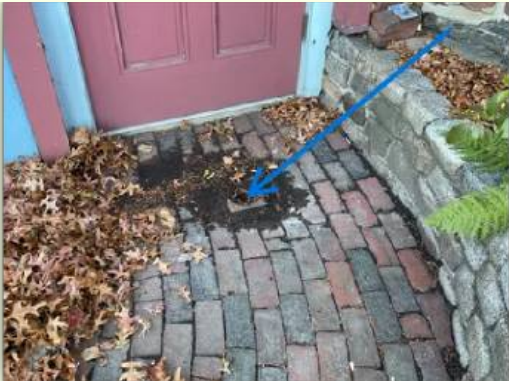
🔧 **(E1-13) In Need of Repair:** There was an exterior drain at the left rear rear of the building. If this drain should clog there is potential for basement water penetration. I recommend that this drain be kept clear of debris at all times. I also recommend that information be obtained as to where this drain terminates.

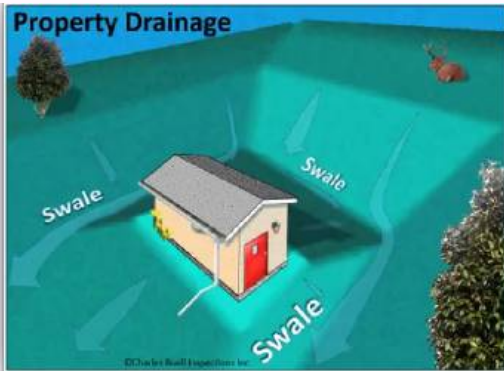
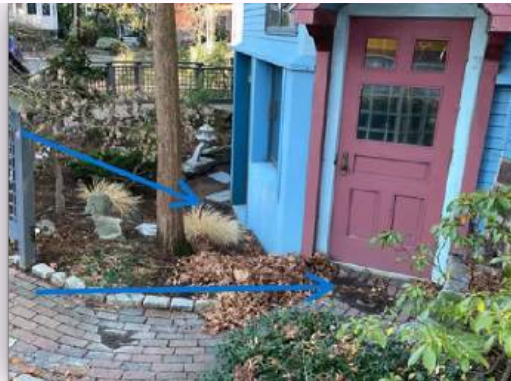
🏠 **(E1-14) Future Repair:** There was reverse grading at the left hand side of the property. Proper grading sends water away from the house. Reverse grading allows water to flow towards the foundation, and this excess water may eventually end up in the basement. The land should slope away from the house at least 1 inch per foot for the first 6-10 feet. I recommend that the basement be carefully monitored for seepage and basement dampness. I also recommend that a landscape contractor inspect the area and regrade as needed.

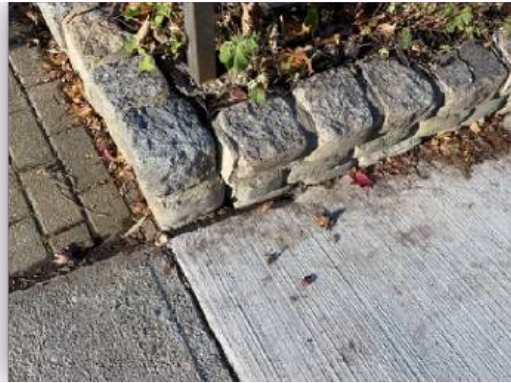
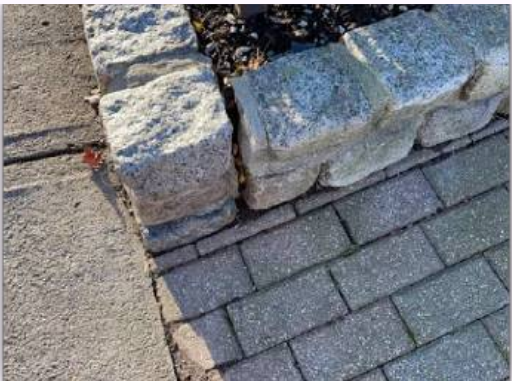
**(E1-16) Future Repair:** The retaining walls at the front of the house were too small and have shifted as a result. Retaining walls either need weep holes to allow drainage to reduce the hydrostatic pressure or they need mass to stand upright. These walls were too small and did not have weep holes and thus are leaning and cracked. I recommend that the small retaining walls be rebuilt.

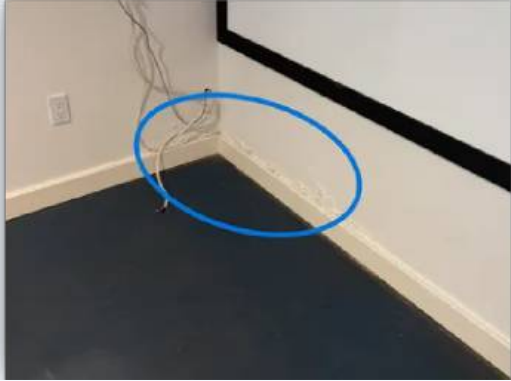
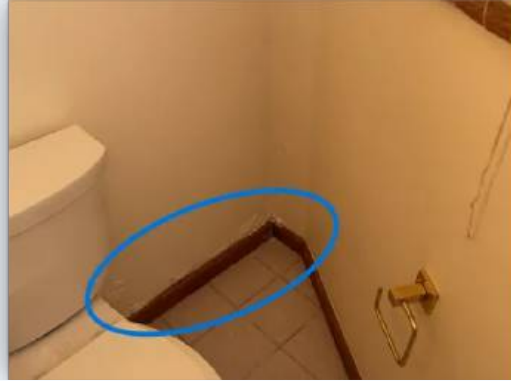
🔍 **(SC-1) Due Diligence:** At the time of inspection the basement was damp and water stained in locations around the perimeter. It is very difficult to locate the water table from a visual inspection. Furthermore it is very difficult to determine whether the basement will get wet under certain weather conditions. I recommend that the seller be asked to disclose any information of the history of water in the basement. Care should be taken to divert ground water and roof water away from the house.

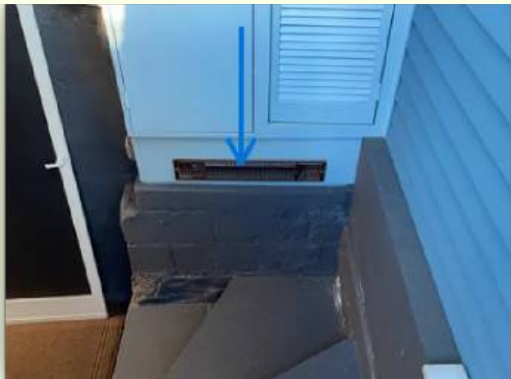
🔧 (HCAC-6) In Need of Repair: There was a hydronic heater in the right rear basement access. It is uncommon to heat this type of space. Information should be obtained from the seller as to what this area was heated and whether the heat source is required. (There did not appear to be any plumbing in the area to keep from freezing.)

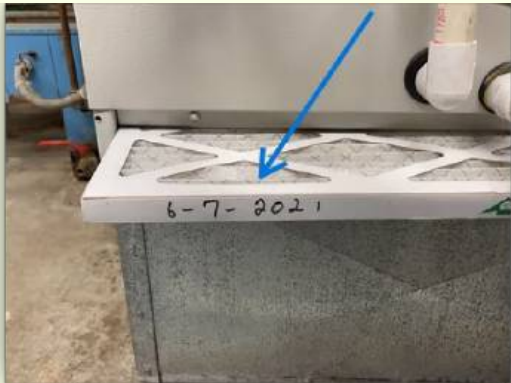
⚠️ (HCAC-8) In Need of Repair: The filter at the basement air handler was much too small and will not filter all the return air. Unfiltered air flowing into the system will reduce the efficiency and reduce the lifespan of the system. I recommend that the air handler be cleaned and the proper sized filter be installed.

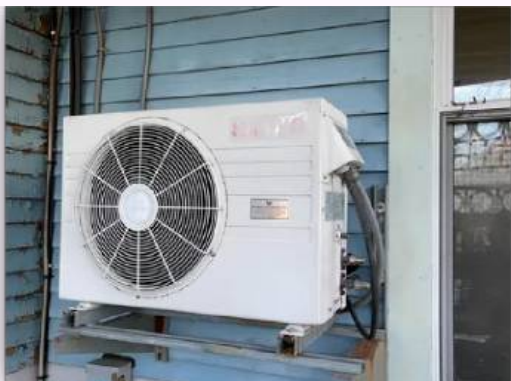
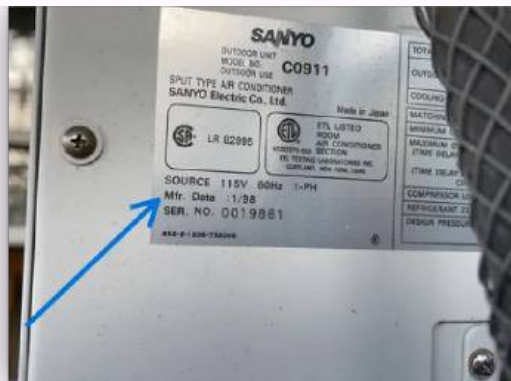
🔧 (HCAC-12) Future Repair: The Sanyo Mini-split AC unit for the 3rd floor rear room was manufactured in 1998. This unit is fully depreciated. The Seasonal Energy Efficiency Rating, or SEER, has changed, requiring AC systems to be more efficient. When the exterior compressor condenser unit is replaced the copper line set and the interior AC coil will also have to be updated to keep in line with the new efficiency standards. This increases the scope and cost of the work. I recommend planning for replacement of the air conditioning system.

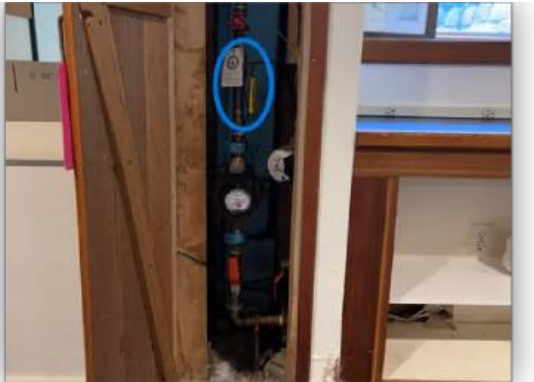
(P-1) Description: The main water shut off was located at the water meter at the left side of the basement. This is for your information.

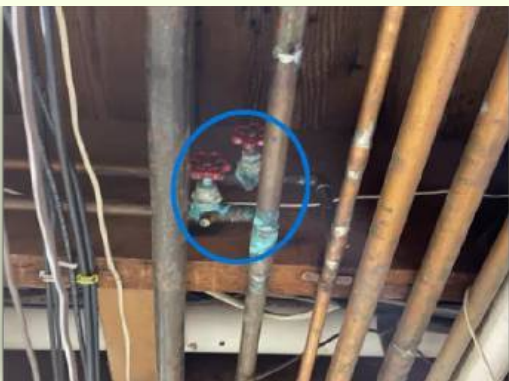
🔧 (P-5) In Need of Repair: There were corroded water supply valves at the basement. There is the potential for leaks at these valves. I recommend that a licensed plumber repair or replace these valves.

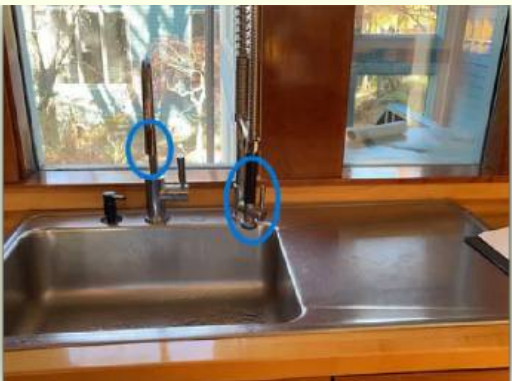
🔧 **(P-8) In Need of Repair:** The spray wand at the kitchen sink did not operate. When activated it caused the water pressure at the sink faucet to pulse. I recommend that these fixtures be repaired or replaced by a licensed and qualified plumber.

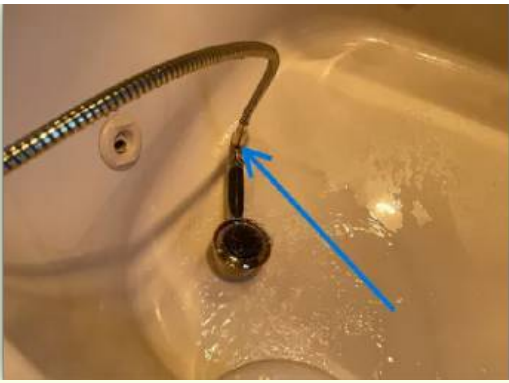
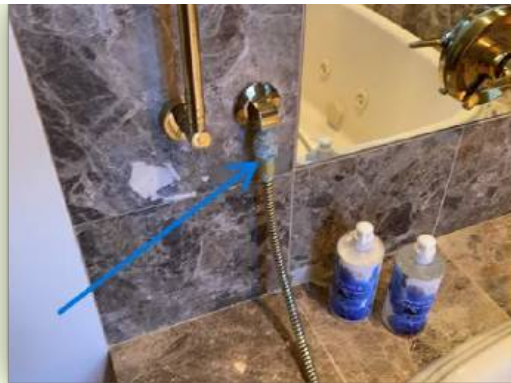
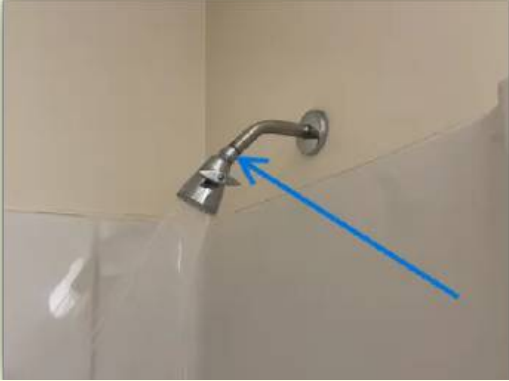
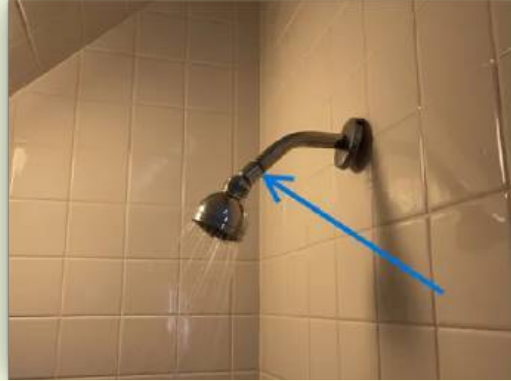
🔧 **(P-9) In Need of Repair:** There were leaking shower heads throughout the house. I recommend that the shower heads be repaired or replaced.

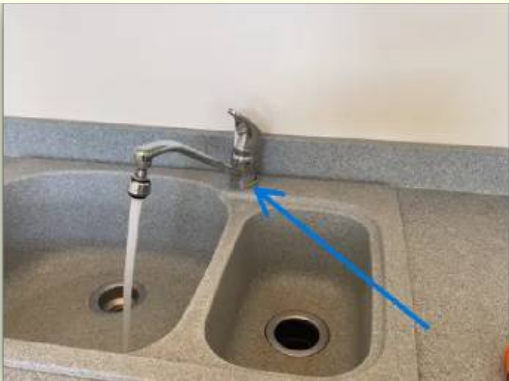
⚠ (P-10) In Need of Repair: The 3rd floor kitchen sink faucet was loose on the counter. I recommend that the fixture be secured by a licensed plumber.

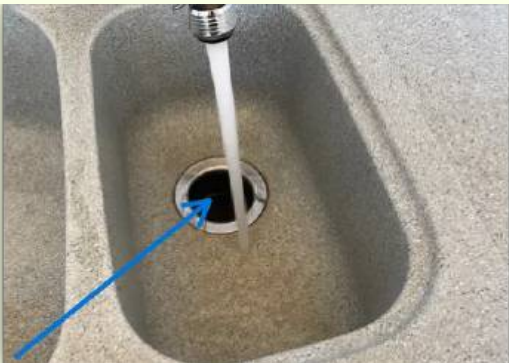
⚠ (P-11) In Need of Repair: The third-floor kitchen sink had a batch feed disposal. The activator was missing and the disposal could not be checked as a result. I recommend that the disposal be repaired or replaced.

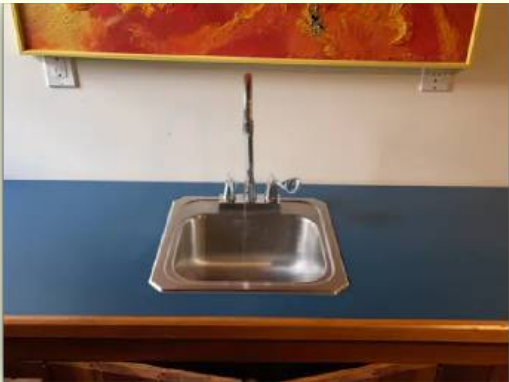
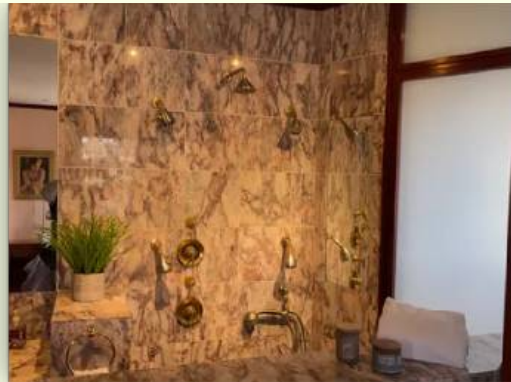
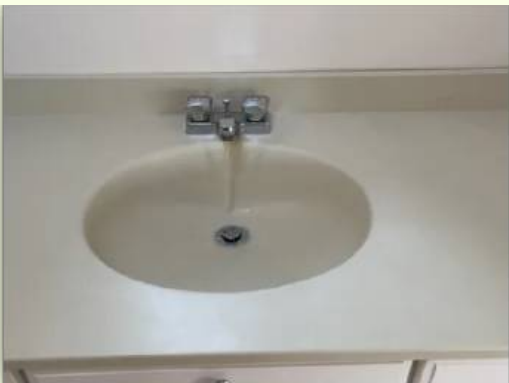
🔧 (P-13) In Need of Repair: At the basement bar sink there was very little water pressure. In the bathroom at the right front of the second floor there was very little water pressure at the showers. At the 3rd floor front bathroom sink there was very little water pressure. I recommend that these fixtures be repaired or replaced by a licensed and qualified plumber.

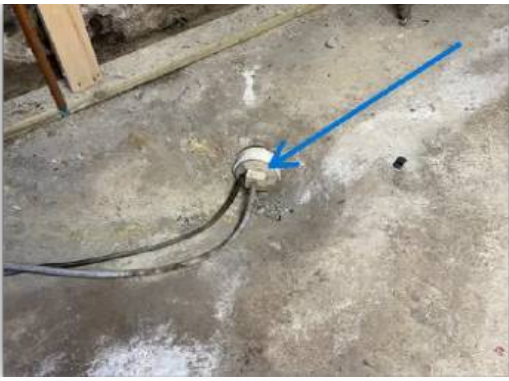
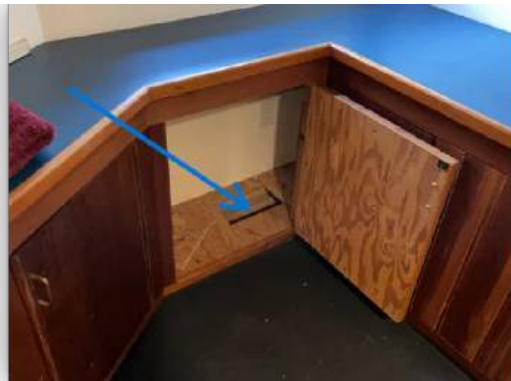
(P-14) Description: The main plumbing clean out was located at the front of the basement. There was also a clean out at the left-hand side of the basement in the cabinets. This is for your information.

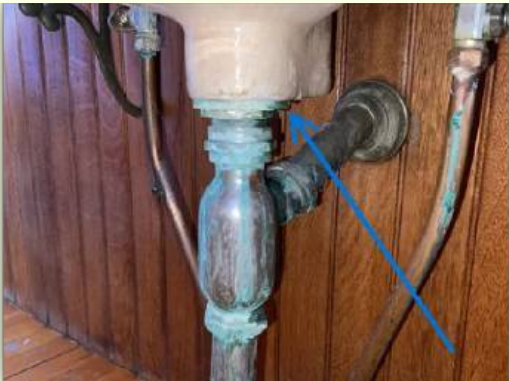
🔧 (P-15) **In Need of Repair:** There was a leak at the 1st floor 1/2 bathroom sink. I recommend that this be repaired by licensed plumber.

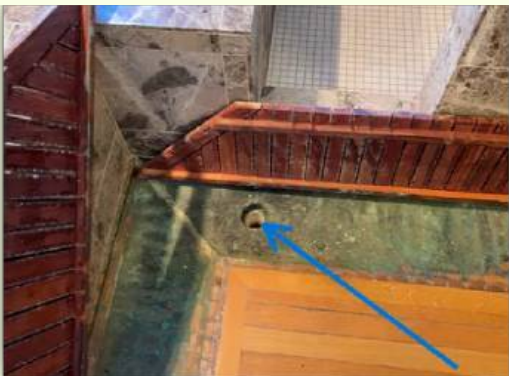
🔧 (P-16) **In Need of Repair:** There was a floor drain at the right rear 2nd floor bathroom. It appears that this was installed to catch any water from the showers that sprays onto the floors. Information should be obtained from the seller as to where this drain terminates.

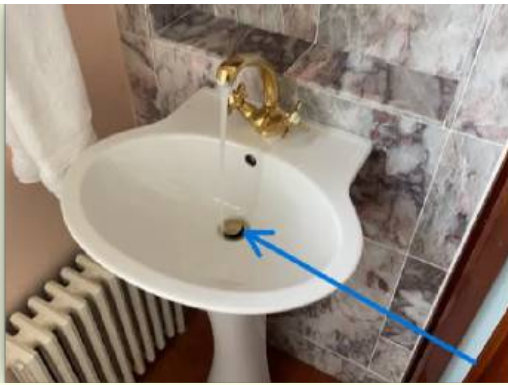
🔧 (P-17) **In Need of Repair:** Many sink/tub pop-ups did not operate in the house. There is no way to hold water in the fixtures with these pop-ups. I recommend that a licensed plumber repair or replace the pop-ups.

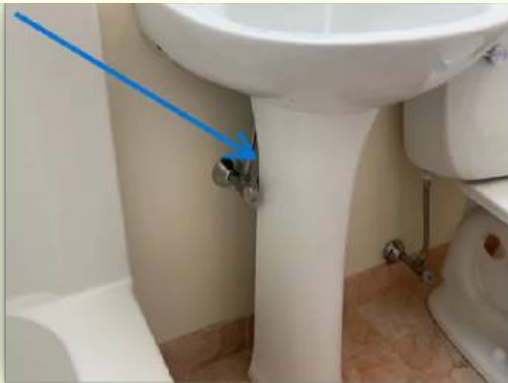
🔧 **(P-18) In Need of Repair:** In the 3rd floor bathroom the tailpiece that connects the sink drain to the trap was corroded. I recommend that a licensed plumber replace this tailpiece.

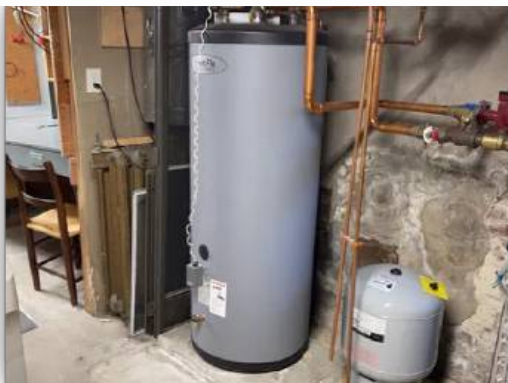
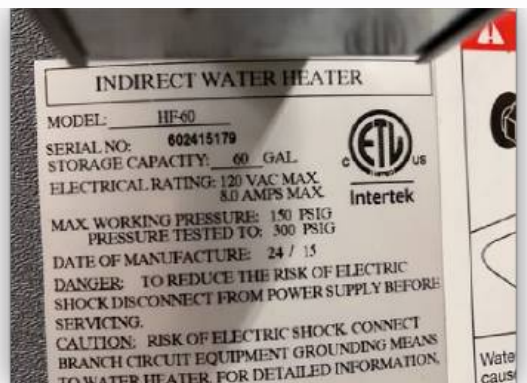
(P-19) Description: The Heat-Flo indirect fired water heater was manufactured roughly 10-15 years ago. Indirect fired water heaters generally last 20 years. This is for your information.

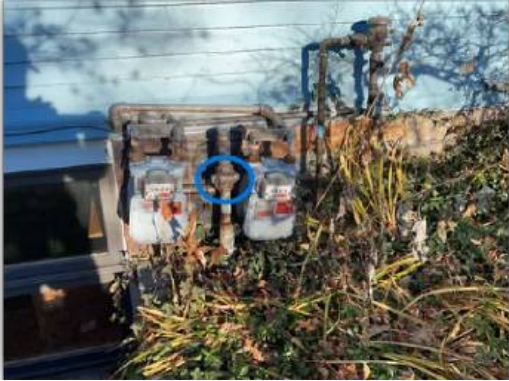
(P-20) Description: The main gas shut off was located at the gas meter at the exterior. This is for your information.

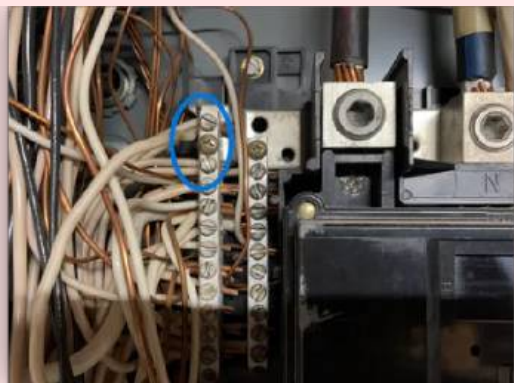
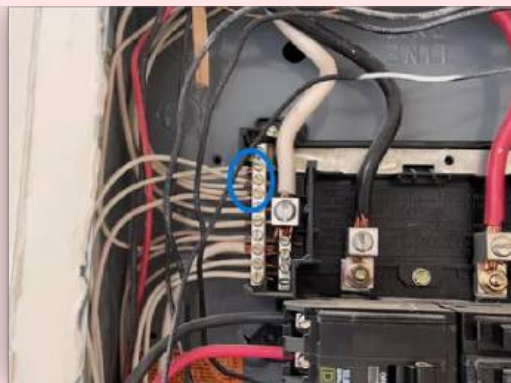
⚡ (E-2) Safety Issue: In the main electric panel, there was more than one neutral attached under one screw and neutrals attached under one screw along with one or more grounds. Only one neutral should be attached under

one screw to ensure that a neutral does not come loose. A loose neutral can overheat and cause a fire. I recommend that a licensed electrician properly wire the neutrals in the electric panel.

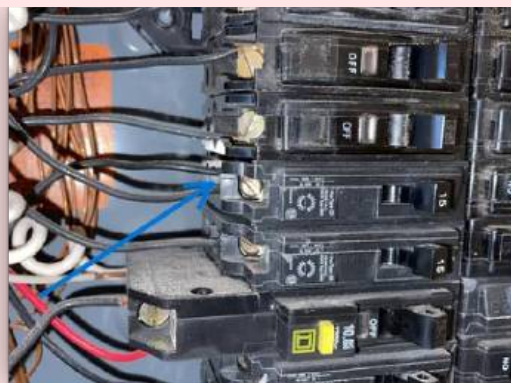
⚡ (E-3) Safety Issue: There were double taps in the electric panels. Double taps in the electrical system are a safety hazard; one wire, not two, should connect the circuit to the breaker or fuse lug. People double tap to add more circuits to an electrical system without installing a new breaker. This can be dangerous because two wires cannot be properly tightened and may cause arcing and a fire. I recommend that a licensed electrician correct this problem.

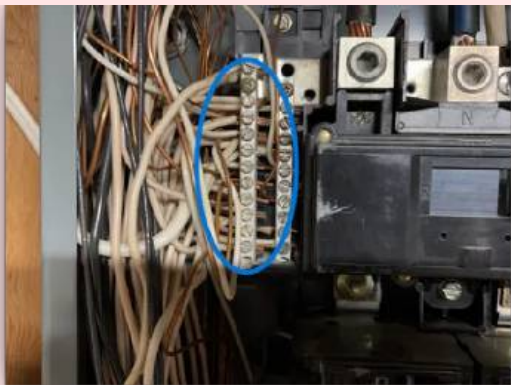
(E-6) Safety Issue: The sub panel in the basement was not properly grounded. The ground wires and neutral wires should not be bonded to the same terminal bar in a sub panel. The neutral wires should be independent of the grounding system all the way back to the main panel. I recommend that a licensed electrician properly wire this sub panel.

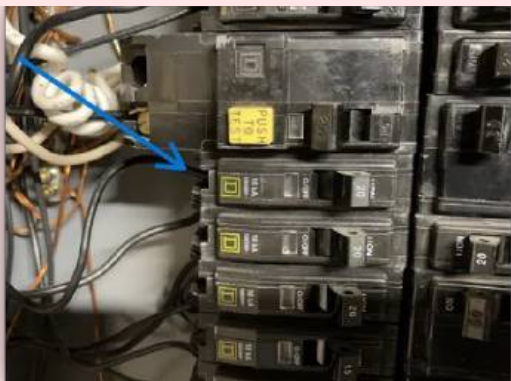
(E-7) Safety Issue: Over fused circuits were observed in the basement sub panel. The presence of over fused circuits, meaning that a 20-amp fuse serving a #14 gauge wire, which is only rated for 15-amperes, is a safety hazard. The branch circuit wires can heat up and cause fires. I recommend that a licensed electrician repair this problem and determine if there are too many electrical receptacles and lighting fixtures on this circuit.

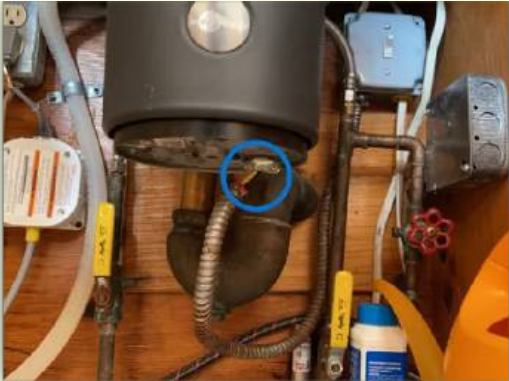
⚡ (E-8) **In Need of Repair:** The wire to the disposal was not secured with a clamp. If pulled, the wires could loosen. This is a shock and fire hazard. I recommend that a licensed electrician install the proper clamp on these wires.

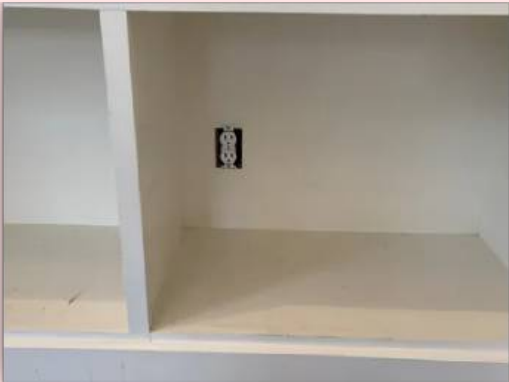
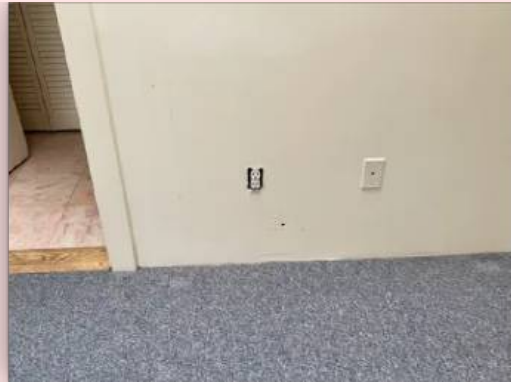
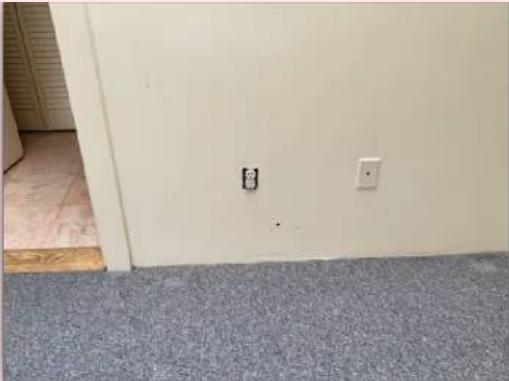
⚡ (E-9) **Safety Issue:** There were missing cover plates at the 3rd floor. There were live wires exposed at these locations. I recommend that cover plates be installed.

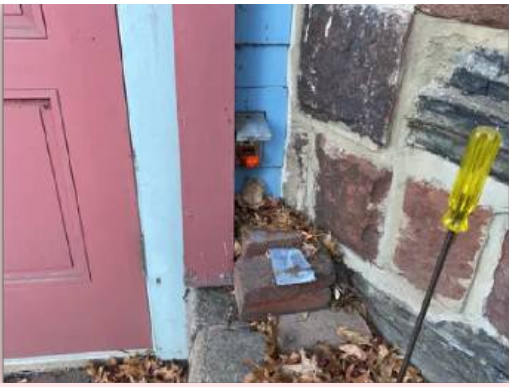
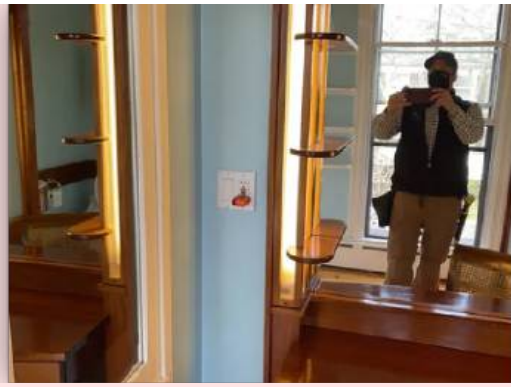
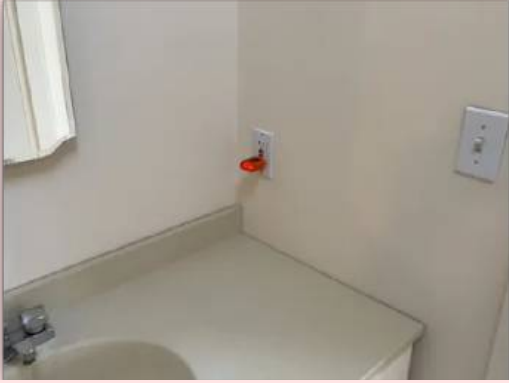
⚡ (E-10) **Safety Issue:** The GFCI at the left front, exterior and in two bathrooms did not trip when tested. All receptacles within 6 feet of water, in the garage, in unfinished areas of the basement, and on the exterior of the house should be equipped with ground fault circuit interrupters (GFCI). GFCI's detect the amperage flow going in and out of the receptacle. If this flow varies by as little as .005 amps, the receptacle will trip. These receptacles should be tested on a monthly basis, if they are not tested they frequently get stuck in the "on" position and will not trip when needed. I recommend that a licensed electrician replace the GFCI's where needed.

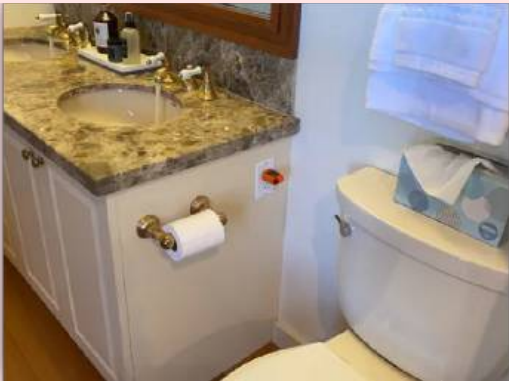
⚡ **(E-11) Safety Issue:** The electric receptacles at the right rear 2nd floor bathroom were not GFCI. I recommend that a licensed electrician install GFCI's where needed.

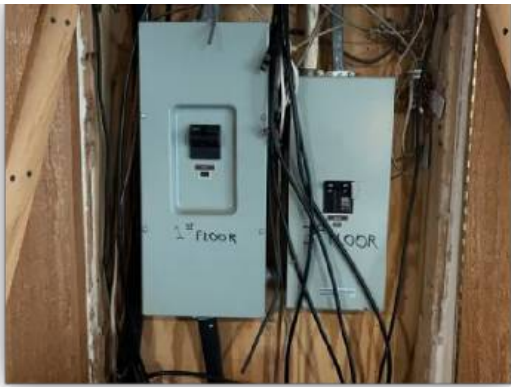
200-amp main breaker; 100-amp main breaker

(E-13) Description: The main was located at the basement and the sub panels were located in the basement, the 2nd floor rear hall and the 3rd floor. This is for your information.

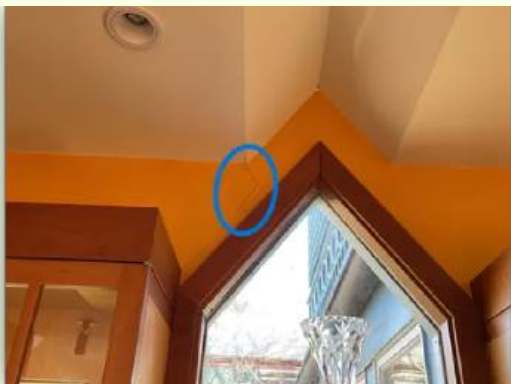
⚠ (I-1) In Need of Repair: There were cracks in the wall in the kitchen. I recommend that a qualified painter prep and paint these areas. I recommend monitoring the cracks for further movement.

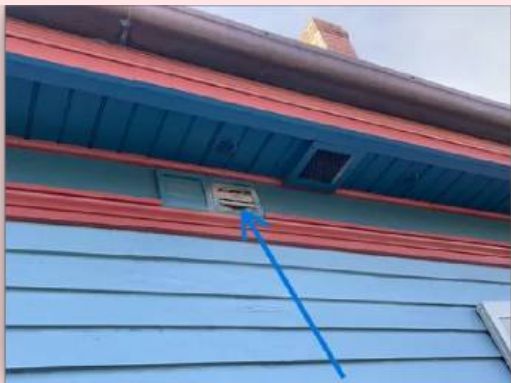
⚡ (I-3) **Safety Issue:** There was lint and nesting material in the dryer vent. This is a fire hazard and also reduces the efficiency of the system. I recommend that the vent be cleaned out and be kept clean of lint.

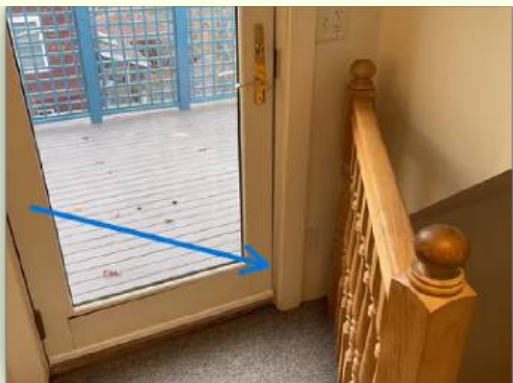
🔧 **(I-8) In Need of Repair:** The third-floor rear deck door did not close all the way, because of this the bottom lock would not engage in the door jamb which allows the door to lock. I recommend that the door be repaired or replaced so that it functions properly.

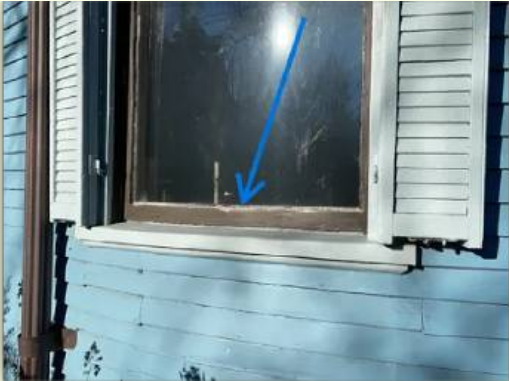
🔧 **(I-9) In Need of Repair:** The window putty was chipping and coming loose. Too much loose window putty can lead to loose window panes. This will reduce the efficiency of the house. I recommend that the windows are re-glazed or replaced. Consideration should be taken on repairing an already old and worn window.

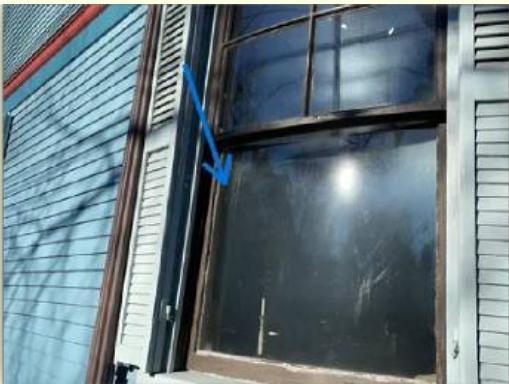
🔧 **(I-10) In Need of Repair:** There was a broken window in the living room. This will allow cold air into the house and also create a potential for injury. I recommend that this window be replaced.

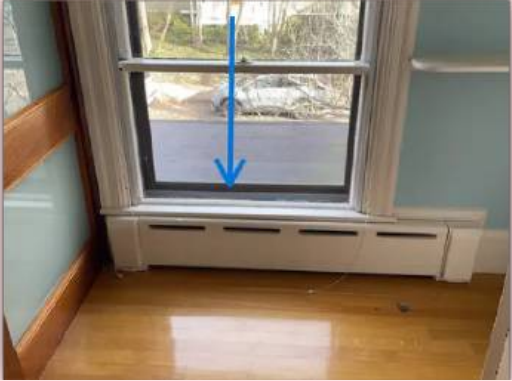
⚡ (I-13) **Safety Issue:** There were windows at the 2nd floor front bathroom that were within 18 inches of the floor. When glass is within 18 inches of the floor there is a potential for injury should someone fall against the glass. All glass near the floor should be tempered safety glass. I recommend that these windows be repaired or replaced to prevent injury.

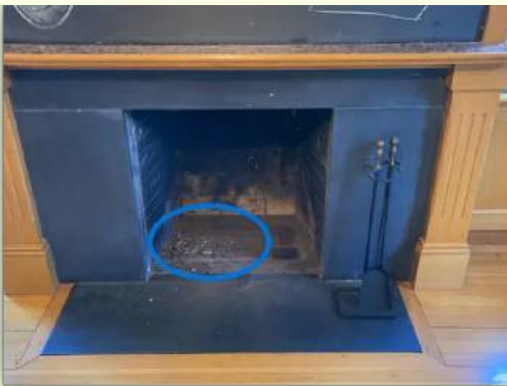
🔧 (FWS-1) **In Need of Repair:** Debris from the flue fell down into the fireplace when the damper was opened at the right front first floor fireplace. This suggests an unlined chimney. The flues at the 2nd floor were not visible or readily accessible as the dampers were stuck shut. I recommend that the flues be cleaned by license to chimney sweep and further inspected. If the fireplaces are to be used a stainless steel liner would most likely need to be installed.

Debris

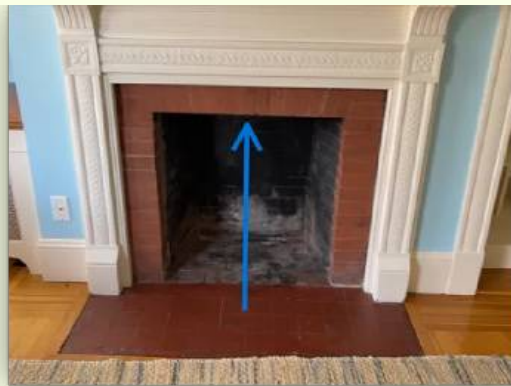
Damper did not open

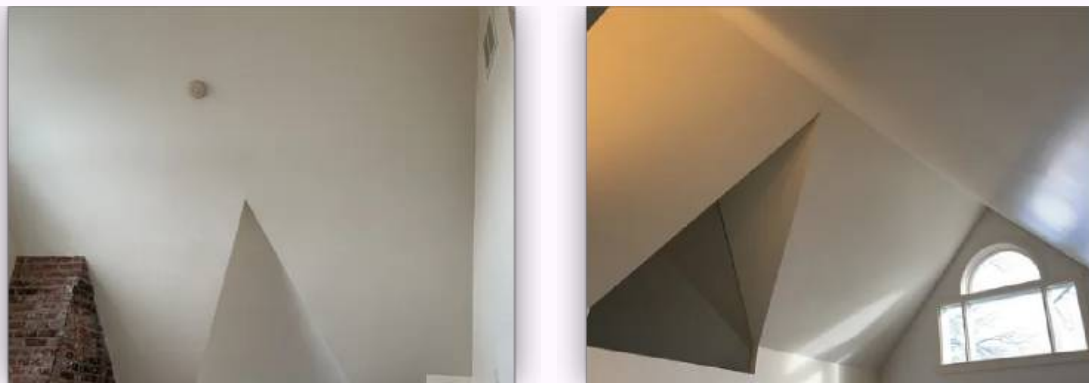
📺 **(IV-1) Future Repair:** There was less insulation in the attic than required for optimal energy efficiency. There will be heat loss in the cold weather. Today's standards call for r-37-r-49 in the attic. This is roughly 12-18 inches of fiberglass or cellulose insulation. Proper insulation increases the energy efficiency of the house, keeps the house cooler in summer, and reduces the chance of ice dams. I recommend that more insulation be added to the attic. I recommend a Mass Save energy audit (masssave.com). The Mass Save program provides significant rebates for work to improve the energy efficiency of a home. The 3rd floor would be very difficult to insulated by

today's standards as the ceilings are all cathedral. Improving the efficiency of the top floor would involve gutting the interior space or insulating from above when the roof is replaced.
